Finite Element Analysis for Telescopic Deformation and Tearing Rupture of Wrinkled Pipe

Navid Nazemi, Sreekanta Das and Sara Kenno

Department of Civil and Environmental Engineering, University of Windsor Windsor, Ontario, Canada

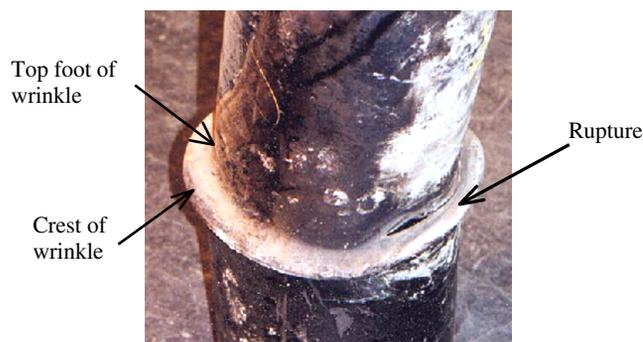
From the field inspection and the description of the load history, it was understood that no strain reversals occurred in this NPS10 field line pipe (Fig. 1). From physical inspection of the ruptured line pipe, it was felt that the pipe wall in the wrinkle region experienced a tearing-type rupture (rupture due to sliding and rubbing of one surface of the pipe against another) due to application of transverse load. It was felt that a wrinkle formed under an axial deformation and with or without presence of internal pressure.

Subsequently or simultaneously, a transverse load above the wrinkle might have caused the telescopic-shaped deformation of the wrinkled line pipe and a tearing rupture at the top foot of the wrinkle (Fig. 1). However, the actual load and deformation combination that caused the telescopic-deformation shape and tearing rupture was not known. A load not aligned with the longitudinal axis of the line pipe is termed a transverse load in this paper.

Fig. 1 Tearing rupture in wrinkle of field NPS10 line pipe
