Ship Grounding over Rock and Shoal

Lin Hong and Jørgen Amdahl

Department of Marine Technology, Norwegian University of Science and Technology
Trondheim, Norway

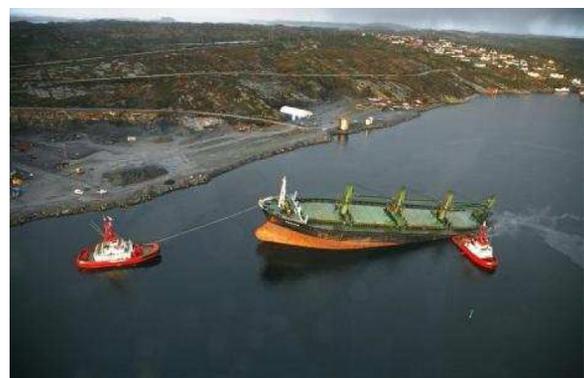
Fig. 1 Cargo ship *MS Server* after grounding outside Fedje, Norway

Potential massive oil spills resulting from ship accidents, such as collision and grounding, constitute a serious threat to the conservation of marine environments. Although there have been significant advancements in both ship design and operation, the risk of collision or grounding is never eliminated. This is demonstrated by the continuous reports of collision and grounding incidents. One recent high-profile accident involved the *Selendang Ayu*, a cargo ship that ran aground and broke in two off Unalaska Island in 2004. It created the worst Alaskan oil spill since the *Exxon Valdez*. Along the Norwegian coast, the cargo ship *MS Server* grounded and split in half outside Fedje in 2007, as seen in Fig. 1.
